Performance of Thin Unbonded Concrete Overlays on High Volume Roads

In 2008, Mn/DOT initiated a five year study that examines the performance of two thin unbonded concrete overlay projects: Cell 5 of the MnROAD Phase II (SP 8680-157) and a

section of TH 53 near Duluth, Mn (SP 6916-99). These pavement test locations provide a unique opportunity for researchers to include additional environmental and traffic factors in validating performance results. It is anticipated that the results from these studies will improve the understanding of the behavior of this complicated composite system, which will lead to the development of better distress and life prediction models and ultimately contribute to more sustainable pavement designs.

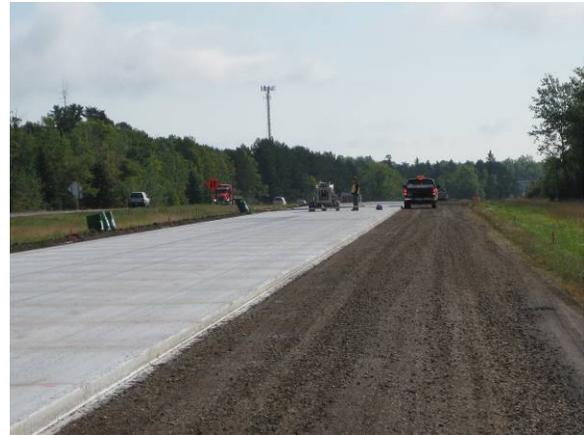
The Mn/DOT Materials and Road Research office installed electronic instrumentation at the time of paving into both the MnROAD and TH53 sections.

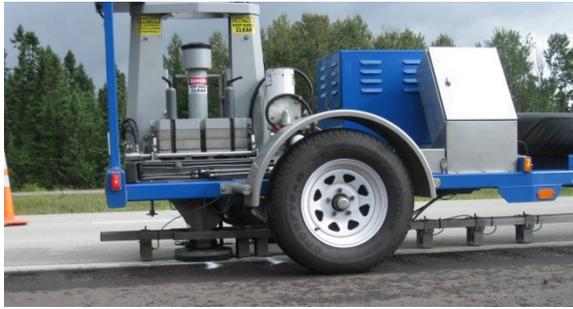
To establish a baseline for performance monitoring, each test section was subjected to rigorous construction inspection and pre- and post-construction testing. As an example, to characterize the structural condition of the existing PCC panels on TH 53, Falling Weight Deflectometer (FWD) testing was done prior to placement of the HMA bond breaking layer, and again shortly after placement of the thin concrete overlay. Initial results indicate that the 5-inch overlay on TH 53 is currently providing adequate structural capacity; however it remains to be seen as to whether this will change over time, or if the 5-inch overlay sections are enough to carry the traffic at the MnROAD test sections. Additional FWD testing will be conducted as the study progresses to

monitor seasonal variations in structural behavior.

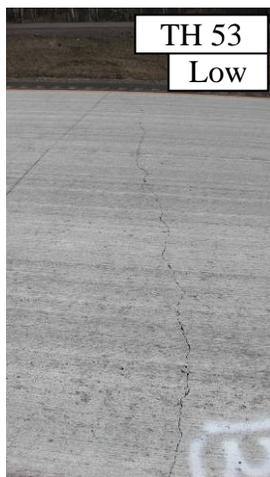
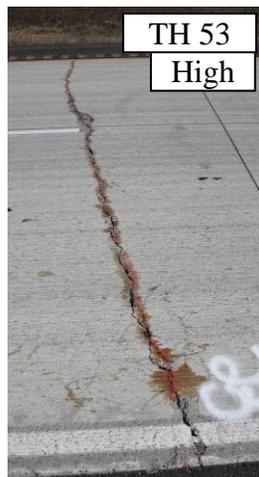
As mentioned previously, inexperience in constructing thin unbonded concrete overlays led to some random transverse cracking on the TH 53 project. A visual distress survey, conducted in April 2009, revealed that approximately 40 cracks had formed in the overlay over the nearly nine mile project length. These cracks had severity ratings of: 7% high, 41% medium, and 51% low.

Both overlay projects were constructed in 2008, and due to their lower thicknesses, placed more quickly than a conventional overlay. This created some issues on the TH53 project, as the transverse joint saw crews were often unable to keep ahead of the faster setting thin concrete overlay. This could possibly be the cause of some early random transverse cracking; however, further analysis is needed.

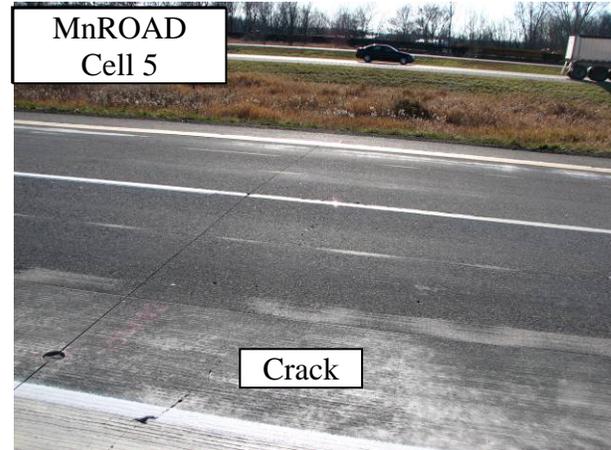
The 4 inch thick overlay test sections at MnROAD began to exhibit noticeable transverse and corner cracking near the joints during the spring of 2009. The specific cause of these cracks is under investigation, but could be linked to the artificially distressed underlying

joints, or excessively curled panels due to long panel lengths in relation to layer thickness.
